## Measuring the Condition of Saline Wetlands Threatened by Agricultural

### Intensification<sup>\*1</sup>

C. CASTAÑEDA and J. HERRERO

The saline wetlands, or “saladas”, of Monegros Desert, NE Spain, contain biodiversity that depends on the establishment of a prognostic monitoring system that can warn of approaching irreversible damage. In the context of a lack of existing biodiversity inventories for the saladas, we have determined their state of conservation and vulnerability using seven physical indicators: escarpment continuity, cropping, stone dumping, size, water occurrence, distance to roads, and proximity to irrigated areas. These features are combined into three meaningful indexes, i.e., conservation, current vulnerability, and future vulnerability, thus creating an assessment of the preservation or degradation of saladas in the context of encroaching agricultural irrigation projects. The proposed indexes produced consistent results and showed that a great number of the Monegros wetlands are threatened, regardless of their size or frequency of water occurrence. Only 20% of the saladas studied are classified as being in a *good* or *very good* conservation, whereas 50% a

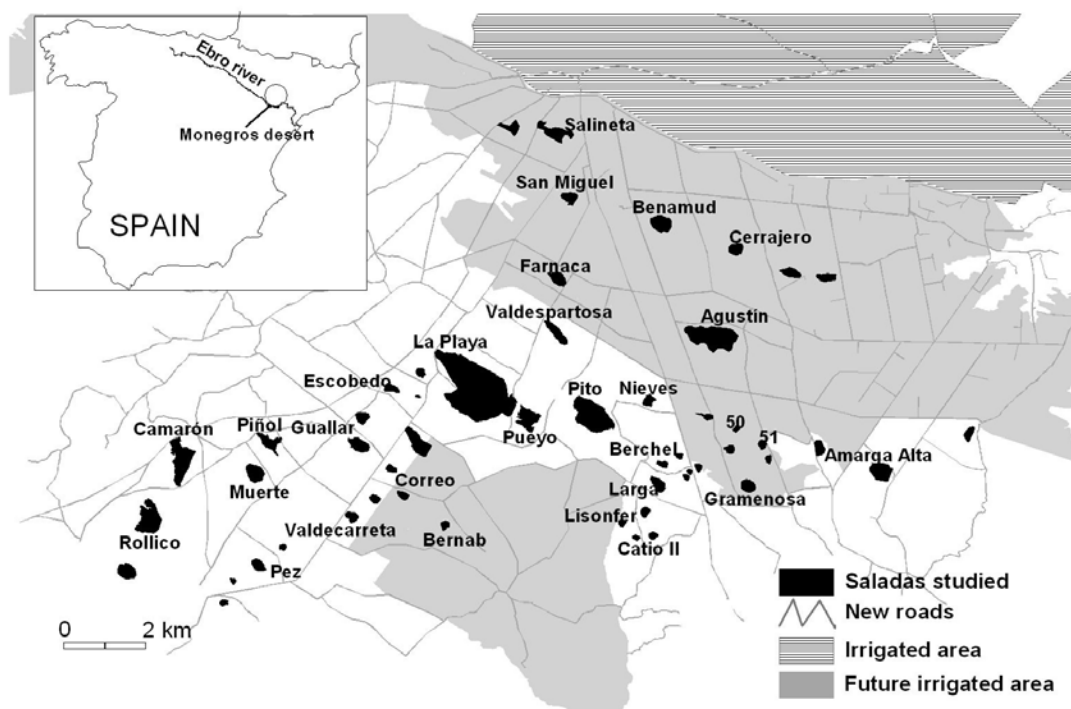
Fig. 1 Roads in 1988 (a), and new roads in 2003 (b), superimposed to the August Landsat image of 5TM and ETM+ sensors, respectively (RGB 543). The currently irrigated area appears in green with this band combination

More than a hundred saladas were inventoried in the region two decades ago. Of these, only 53 (Fig. 1) were recognized in our updated *Inventory 2003* (Castañeda and Herrero, *in revision*). Ranging from less than 1 ha to more than 200 ha, the saladas lie hidden in the agricultural landscape, occupying the lowest positions of the gentle undulated topography. The saladas bottom elevation ranges between 310 and 370 m a.s.l. and they are shaped by escarpments of up to twenty meters tall which are aligned in the prevalent tectonic and wind direction, NW-SE.

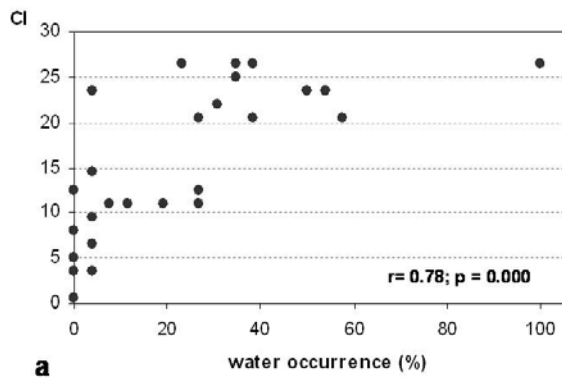
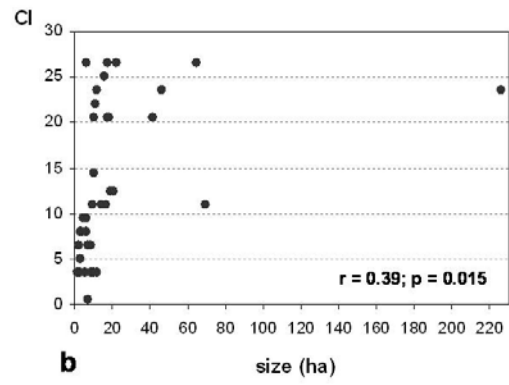
Fig. 2 Values of the salada Condition Index, CI, compared with water occurrence (a) and salada size (b).

The CI values had a slight positive relationship with the water occurrence with a Pearson correlation coefficient of  $r = 0.78$  ( $p = 0.000$ ) and had no observed relation ( $r = 0.39$ ;  $p = 0.15$ ) to the size of the salada (Fig. 2). Even when the more frequently flooded saladas yield high values of CI, the weak relationships denote an anthropic control of the conservation state rather than a natural one.

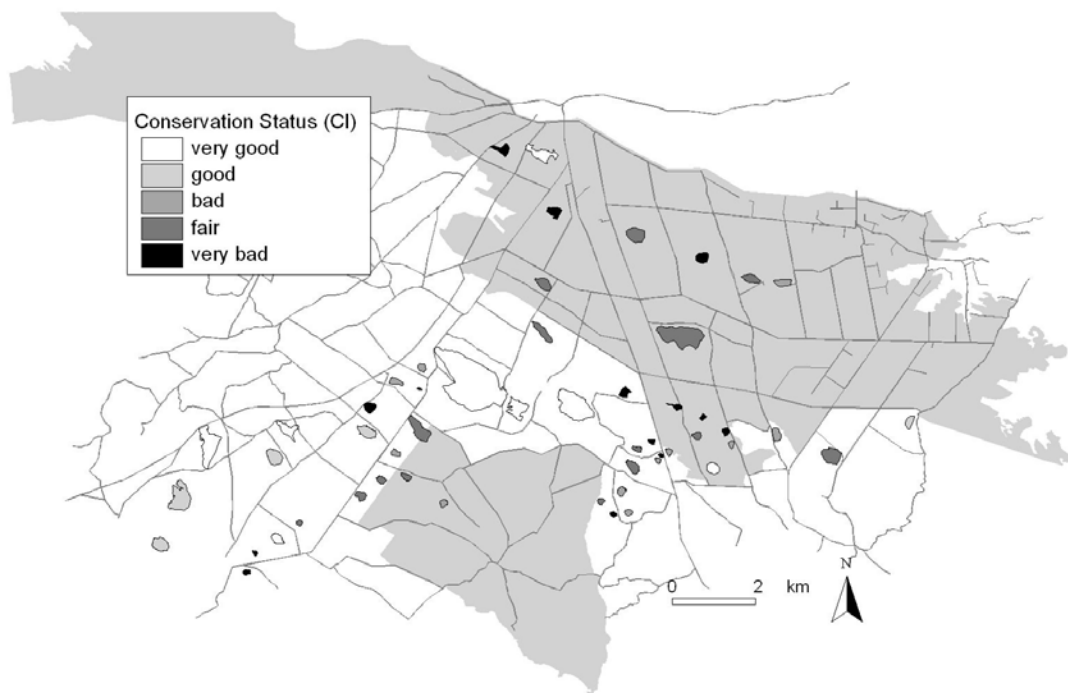
Fig. 3 Conservation status of the saladas as established using the Conservation Index (CI) index, which was defined with three field features: escarpment, cropping, and stone dumping.

From the thematic values (Table IV), 20% of the saladas are in *good* or *very good* conservation (Fig. 3); they are of playa-lake type, holding water at least some time each year. Almost all of them are surrounded by crops and are affected by stone dumping to different degrees. Half of the saladas have a *bad* or *very bad* conservation; these are primarily the smallest saladas and those strongly influenced by cropping; of these, nine have been completely plowed and nine more are unrecognizable because of stone dumping, debris, and construction. Some 30% of the saladas present a *fair* conservation, with a smooth escarpment and the bottom covered by halophytes. Their soils, with an electrical conductivity  $> 100 \text{ dS m}^{-1}$  (Herrero, 1982), are considered unproductive by the rural population; this has facilitated their conservation, except for stone dumping.

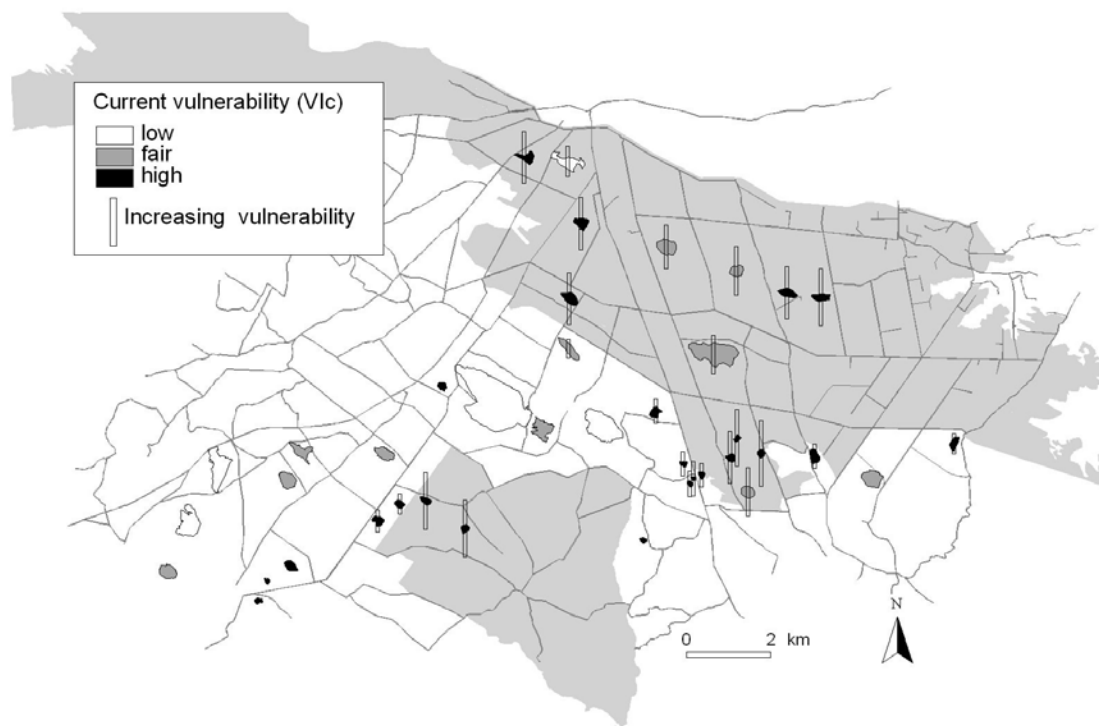
Fig. 4 The current vulnerability of the saladas as established using the Vulnerability Index (VIc), which was defined with three features extracted from remote sensing and GIS analysis: proximity to roads, size, and water occurrence.

This VIc index was applied to the 39 saladas detected by remote sensing. Following the thematic values of Table IV, 60% of these saladas have a *high* current vulnerability (Fig. 4); they are the smallest saladas, ranging from 1.4 to 12.2 ha, and have the least water occurrence. They usually have smooth escarpment but halophytes remain in spite of stone dumping and cropping. Some of them are very close to or are within the irrigated area.

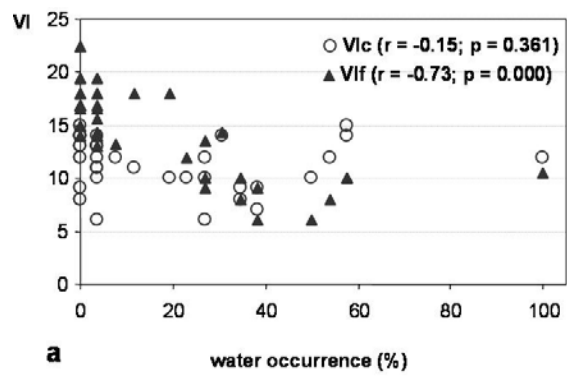
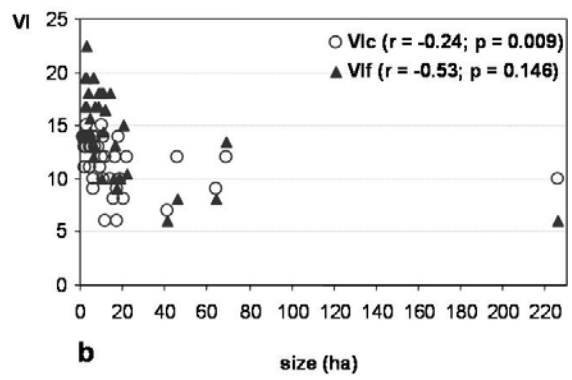
Fig. 7 Values of the two Vulnerability indexes —current (VIc) and future (VI<sub>f</sub>)— compared with water occurrence(a) and salada size (b).

As shown in Fig. 7, the relationships between the vulnerability indexes (VIf and VIf) and the water occurrence or the size of the saladas yield negative Pearson correlation coefficients. The only significant, but slight, correlations are water occurrence with VIf ( $r = -0.73$ ;  $p = 0.000$ ), and size with VIf ( $r = -0.24$ ;  $p = 0.009$ ). These slight correlations parallel that of the CI (Fig. 2) and highlight the rise of anthropic influence. The highest vulnerability values occur in saladas  $< 10$  ha, which are also those with less water occurrence.

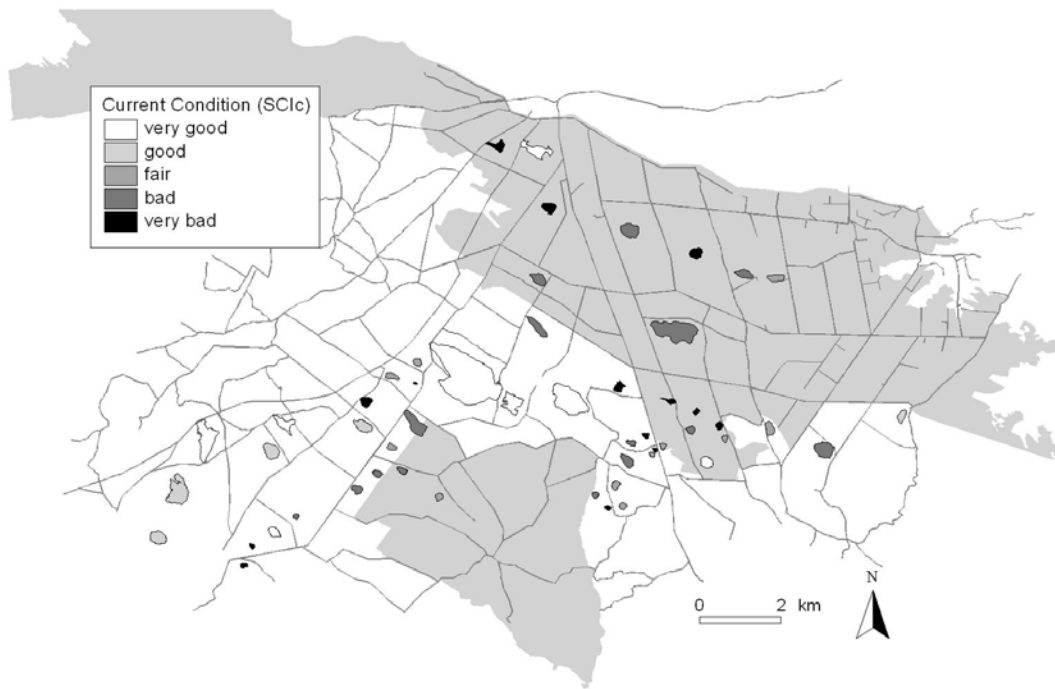
Fig. 6 The future vulnerability of the saladas as established by the Future Vulnerability Index (VI<sub>f</sub>), which takes into account the future irrigated area extent.

The ongoing irrigation works are producing effects in agreement with the VIf categories (Fig. 6). Much more intense alteration is expected when irrigation starts, due to foreseeable irrigation returns and other water flows.
